College of Micronesia - FSM Space Utilization and Facilities Master Plan Study, Part 3 - Detailed Report for the National Campus

Prepared by Beca International Consultants Ltd (Beca)

28 November 2013

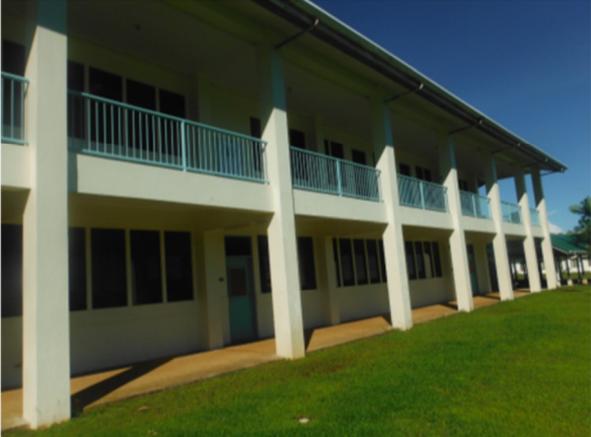
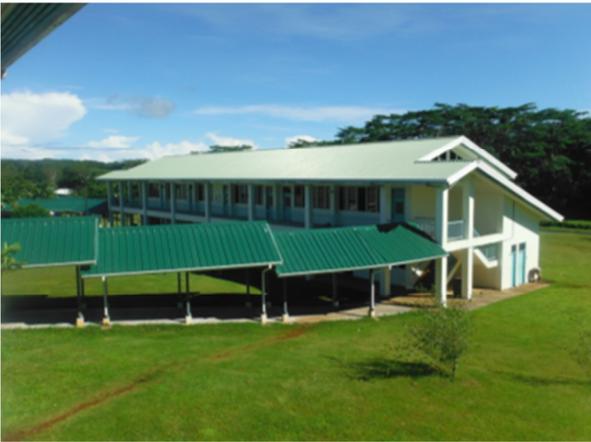
<p>Points to consider for future planning – look at options to create more floor space in the science store room for needed project space by using mobile shelving samples, references</p>	<p>Disabled access - not provided to the second floor</p> <p>Teaching spaces -</p> <p>Amenities, toilets - Toilets on the ground floor at each end of the building – 2 mens/ 2womens</p> <p>Building condition points -Targeted regular maintenance and cleaning to extend asset life. Treat rust and spot prime balustrades immediately. Re-paint roof immediately</p> <p>Building age – 17 years</p>
<p>B – Standard Classrooms</p>

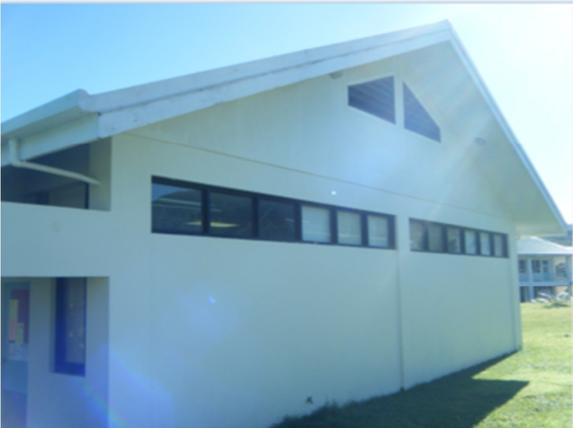
Building	Outline
<p>Building F - Faculty Offices (old)</p>

<p>Building F is a faculty and administration building (Human Resources). It is broken down into seven individual spaces 600sqft in size. These are one lounge and six faculty spaces (400sqft of open office area and a 180sqft faculty head office)</p> <p>Location for its function – Located in a good location within the academic zone</p> <p>Quality and suitability of spaces for its function – Spaces allow for adaptation and function changes - The human resources team have moved into the previous Public Health faculty area in Fall 2013. More open spaces could be created by removing portion of the wall between rooms, also a change in furniture layout to long desks instead of angled desks would increase the number of people who could be accommodated. These spaces could also be converted to seminar rooms if required.</p> <p>Disabled access - Level access</p> <p>Teaching spaces - nil</p> <p>Amenities, toilets - toilets for faculty</p> <p>Building condition points - Evidence of damaged/marked/stained ceiling</p> <p>Tiles Air-Conditioning - DX/Split System Most not used, some not working Profiled Metal Sheet Roof Cladding (Pre-Finished) Evidence of faded paint – re-paint immediately</p> <p>Building age -17 years</p>

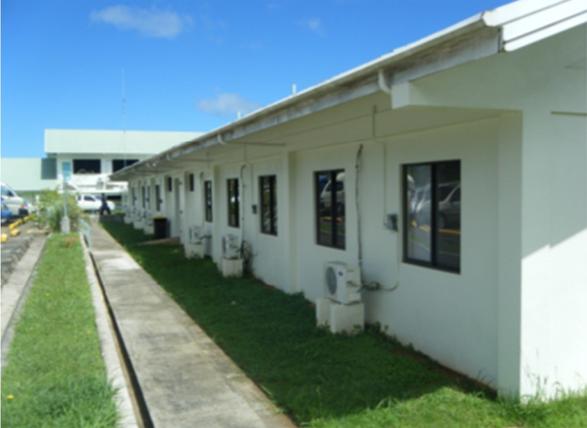
<p>Building F2 - Faculty Offices (new)</p>

<p>Building F2 is a faculty building for language and literature and maths and science.</p> <p>Location for its function - Located in a good location within the academic zone</p> <p>Quality and suitability of spaces for its function – The spaces are more open in the literature area than the cellular layout of the old faculty building. The lounge area is well located at the main entrance as a meeting place and for the exchange of ideas. This is a good layout for any further faculty buildings.</p> <p>Disabled access - Ramp at the rear of the building</p> <p>Teaching spaces - nil</p> <p>Amenities, toilets - toilets for faculty</p> <p>Building condition points - Evidence of settlement walking along hallway, targeted regular maintenance and cleaning to extend asset life.</p> <p>Building age -9 years</p>

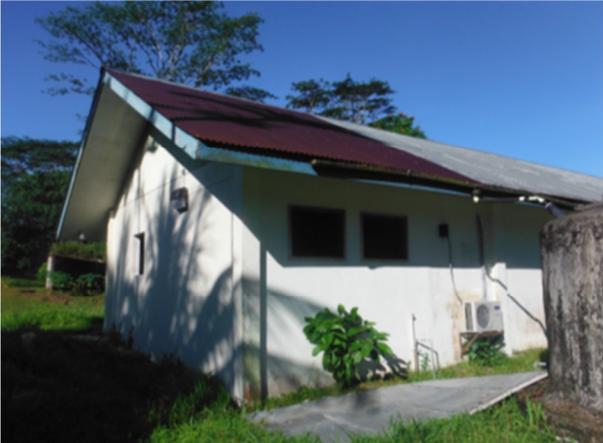
Building	Outline
<p>Building I – Agriculture</p>

<p>Building I is the Agriculture building</p> <p>Location for its function – Located adjacent to the agriculture area</p> <p>Quality and suitability of spaces for its function - Adequate</p> <p>Disabled access - level access</p> <p>Teaching spaces - one</p> <p>Amenities, toilets - 1mens/1women's</p> <p>Building condition points - Replace severely corroded sections of roof and missing/damaged gutters immediately. Review remainder of roof treat rust and roof or replace immediately. Treat borer damage to doors immediately</p> <p>Building age – 17 years</p>
<p>Building J – A + Centre and Art Classroom</p>

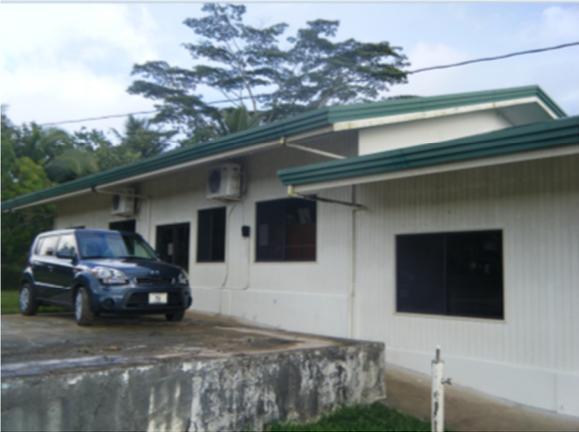
<p>Building J is was formerly the A+ Centre but is now used for Public Health education after an extension in Fall 2013</p> <p>Location for its function – The building is located next to the interface with the public road building on the potential to be an exchange point between the community and the College.</p> <p>Quality and suitability of spaces for its function -</p> <p>Disabled access - Accessible by ramp</p> <p>Teaching spaces – not identified in this study (assume 2 spaces)</p> <p>Amenities, toilets - 1mens/1women's</p> <p>Building condition points - Treat and repair termite/borer damage immediately. Check and repair water damage/leaks to soffit and light fittings immediately. Re-paint roofing immediately.</p> <p>Building age – 4 years</p>

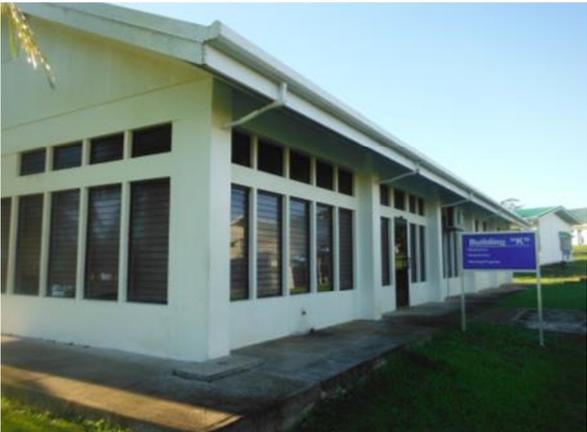
<p>Building K – Book store, Dispensary</p>

<p>Points to consider for future planning – Locate the bookstore, storage and inward goods areas in one place</p>	<p>Building K is the Book store and dispensary</p> <p>Location for its function – The bookstore is separated from the storage area which is not ideal. At the start of the year operations are relocated to the bulk store in Building M to issue resources to students.</p> <p>Quality and suitability of spaces for its function - Book store is not large enough</p> <p>Disabled access - level access</p> <p>Teaching spaces - nil</p> <p>Amenities, toilets - 2 mens/2 womens</p> <p>Building condition points - Review flaking roof paint and re-paint roof immediately</p> <p>Building age – 17 years</p>

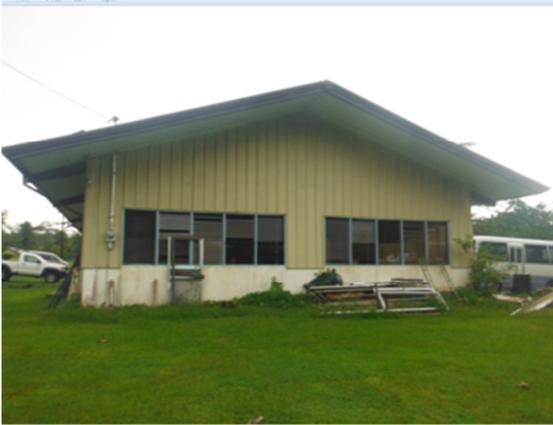
Building	Outline
<p>Building N – Maintenance, CRE, Music Classroom</p>

<p>Building N is the maintenance area, CRE and music room</p> <p>Location for its function – The music room seems disconnected from the rest of the campus - a location in the academic zone in a suitably acoustically treated space would seem more appropriate</p> <p>Quality and suitability of spaces for its function – Wide span building suits the maintenance function</p> <p>Disabled access - level access</p> <p>Teaching spaces - nil</p> <p>Amenities, toilets - 1 mens/ 1 womens</p> <p>Building condition points - Localized roof, gutter and soffit repairs or rust treatment required immediately</p> <p>Building age – 17 years, mid 1990s</p>

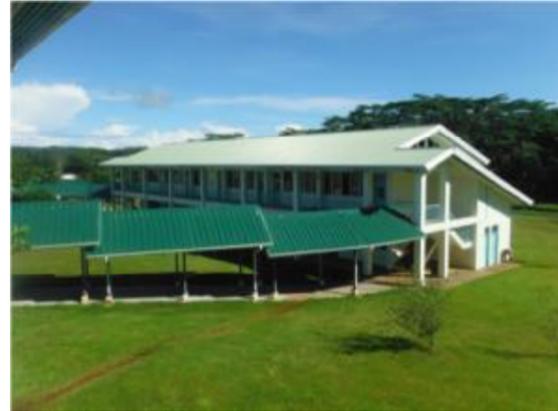
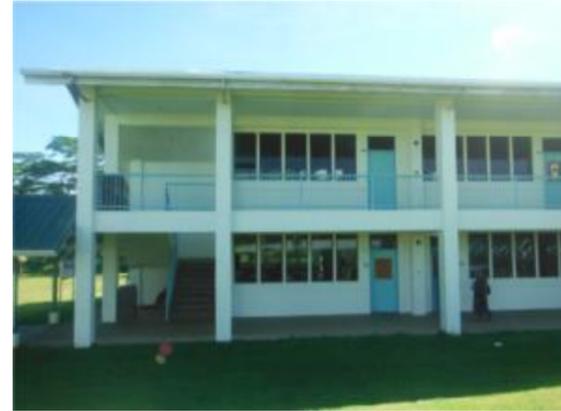
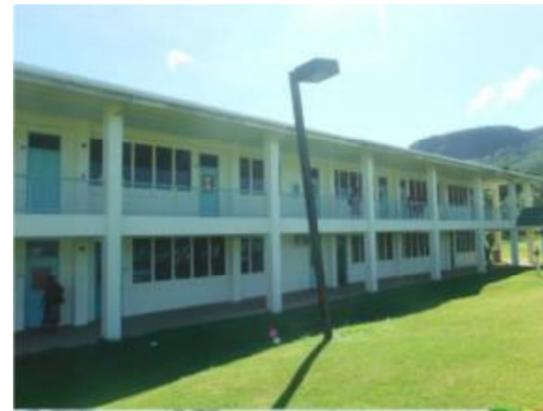
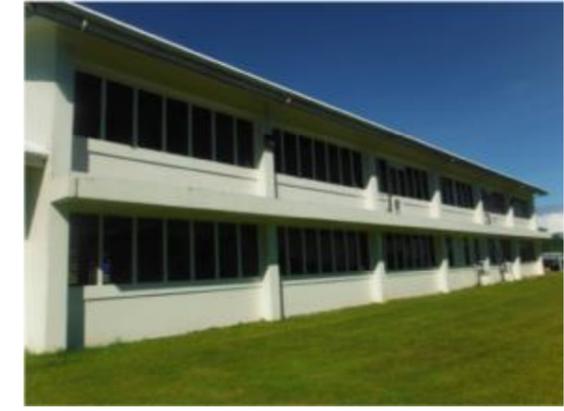
B – STANDARD CLASSROOMS

1.00	Total Sub-Structure	3	50%						0	0	0	0	150,745	0.0%	Timber Doors (Solid/No Glazing)	Evidence of termite damage
2.00	Total Frame	2	30%						0	0	0	0	405,541	0.0%

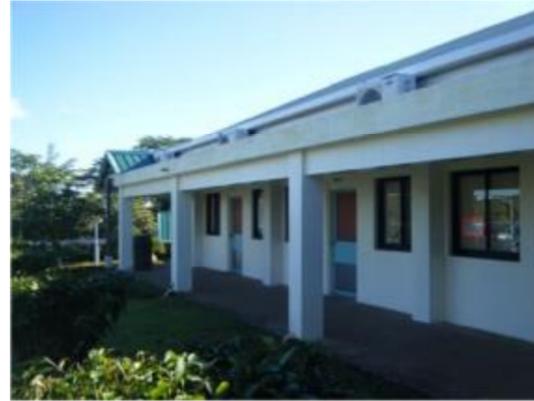
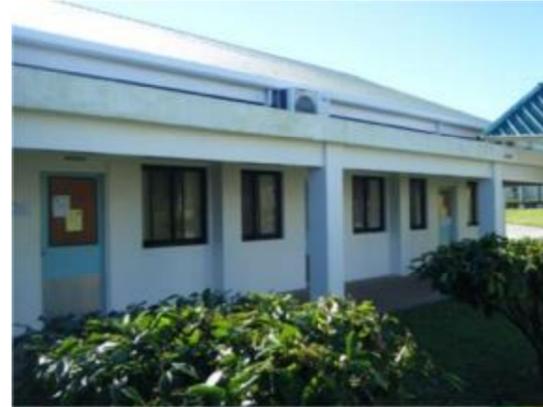
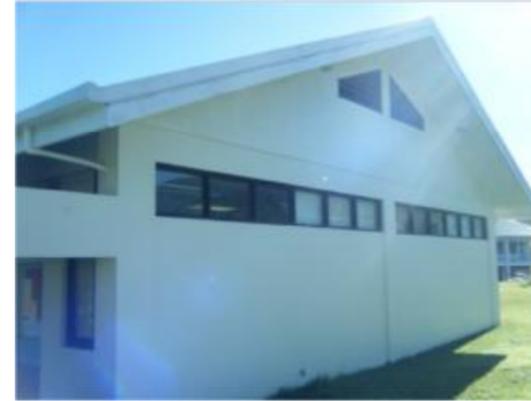
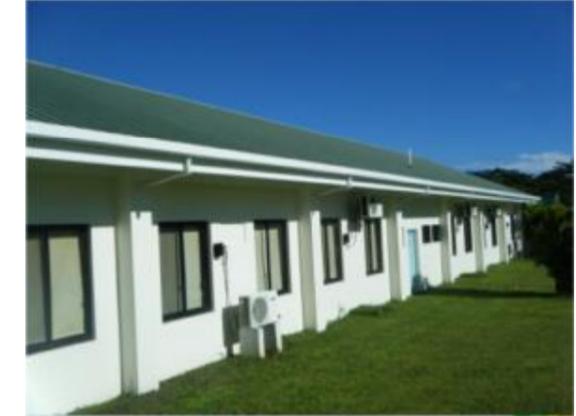
F - FACULTY OFFICE (OLD)

1.00	Total Sub-Structure	3	50%						0	0	0	0	176,662	0.0%	Overall Recommendation/Action Targeted regular maintenance and cleaning to extend asset life. Repair water damage/leaks to ceiling/ immediately. Re-paint roof immediately. Regularly maintain and replace mechanical, fire and special services by 2023

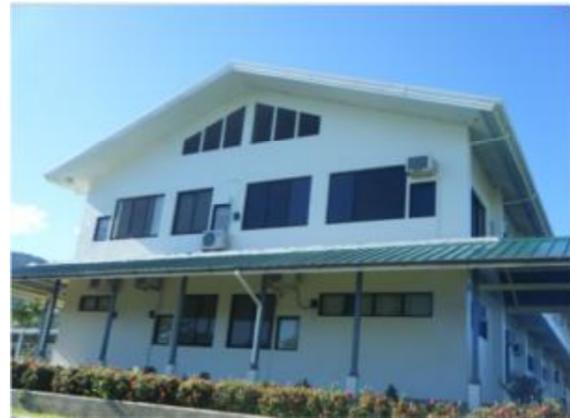
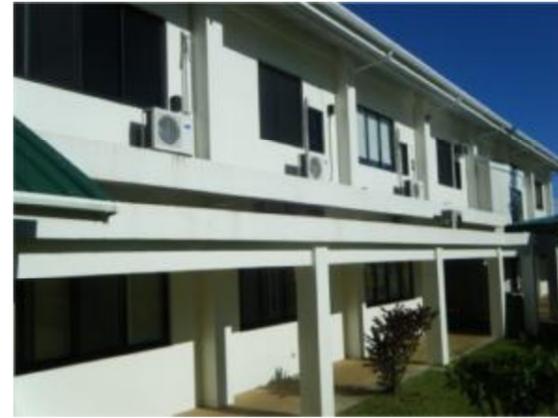
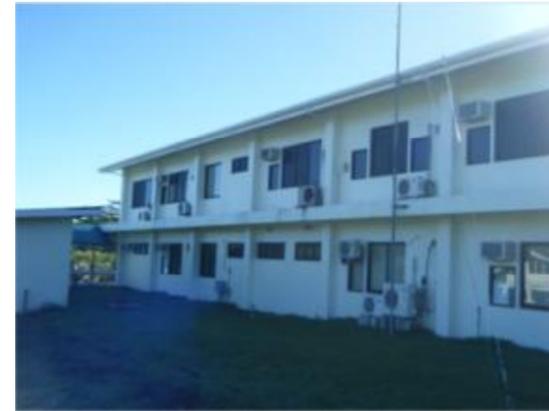
G - ADMINISTRATION

1.00	Total Sub-Structure	3	50%						0	500	0	500	169,772	0.3%	Overall Recommendation/Action Targeted regular maintenance and cleaning to extend asset life. Treat rust and spot prime corroded gutters immediately. Replace roof by 2023. Refurbish floor, wall and ceiling finishes by 2023. Replace 1-2 AC window mounted units immediately. Regularly maintain and replace mechanical, fire and special services by 2023.

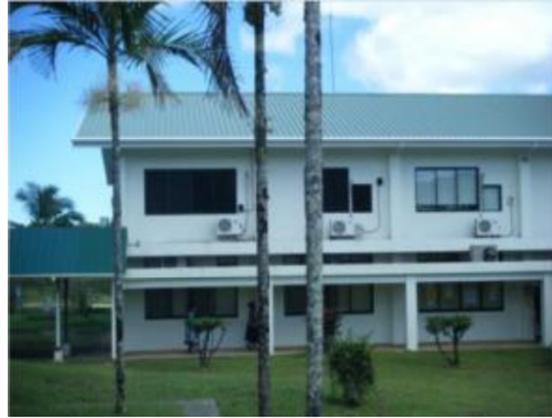
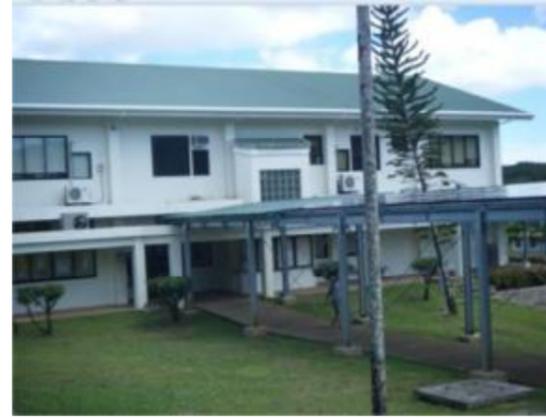
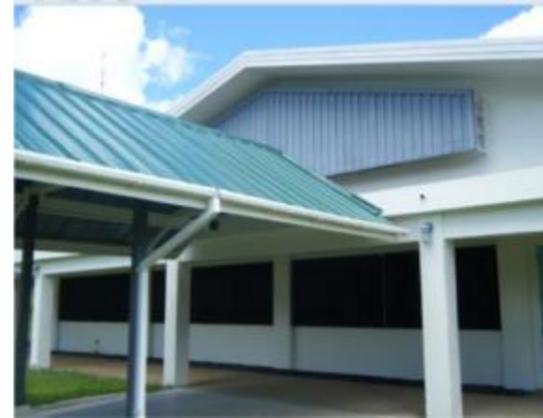
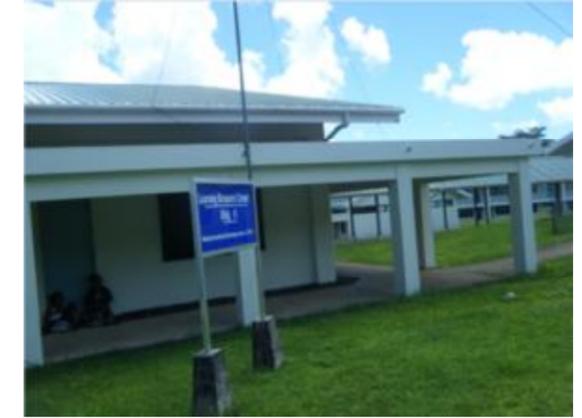
H - LEARNING RESOURCE CENTER AND MITC

1.00	Total Sub-Structure	2	30%						0	0	0	0	243,611	0.0%	Insitu Reinforced Concrete Upper Floor - Canopy	Good condition but not sealed/ protected
2.00	Total Frame	2	30%						0	0	0	0	426,882	0.0%
