College of Micronesia - FSM Space Utilization and Facilities Master Plan Study, Part 3 - Detailed Report for the National Campus

Prepared by Beca International Consultants Ltd (Beca)

28 November 2013

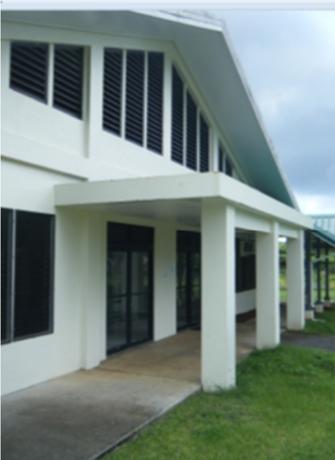
<p>C – Dining Hall</p>

<p>Points to consider for future planning – Remove the</p>	<p>Building C is a dining hall and kitchen with offices along the northern side</p> <p>Location for its function – Well located between the accommodation and academic zone with service access to the kitchen</p> <p>Quality and suitability of spaces for its function – the dining hall is adequate in size for current roll but would need to be larger for an increased roll</p> <p>Disabled access - level access into the building. Stairs at the administration building are a barrier for access for people with disabilities</p> <p>Teaching spaces - nil</p> <p>Amenities, toilets - along the northern side –one mens/ one womens</p> <p>Building condition points -Treat rust and spot prime corroded gutters immediately. Check roof for rust and treat if necessary and re-paint immediately. Repair water damage/leaks to ceiling/soffit immediately.</p>

Building	Outline
<p>partitions to increase the floor area and open up the northern side to cross ventilation and views across the site. Consider outdoor seating</p>	<p>Building age -17 years</p>
<p>Building D – Men’s Residence Hall</p>

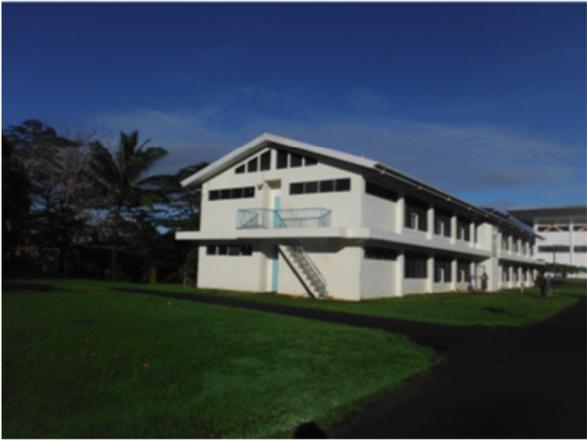
<p>Points to consider for future planning – Increase access to wifi connection - currently patchy connection available</p>	<p>Building D is the two storey men’s residence hall</p> <p>Location for its function – Well located in the accommodation zone adjacent to the basketball hard-court area and the soccer field to the north and the student services facilities</p> <p>Quality and suitability of spaces for its function – The rooms were designed for four students. This has been revised in practice to three students. There are 29 rooms with an ability to accommodate 87 students</p> <p>Disabled access - access only to the ground floor, toilets/showers not designed to be accessible</p> <p>Amenities, toilets - 8 toilets in total</p> <p>Building condition points - Treat rust and spot prime corroded gutters and re-paint roof immediately. Check roof for rust and treat if necessary. Repair water damage/leaks to ceiling/soffit immediately. Refurbish floor finishes by 2023. Regularly maintain and replace mechanical, fire and special services by 2023</p> <p>Building age -17 years</p>

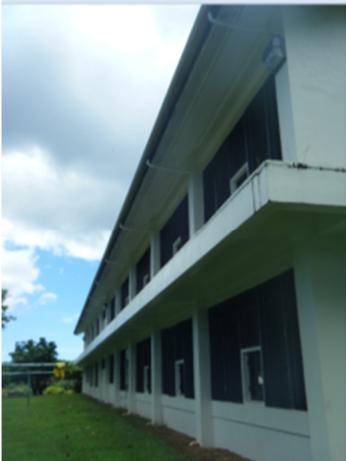
<p>Building E - Women’s Residence Hall</p>

<p>Points to consider for future planning – Provide a place where students can meet with matrons to discuss private issues</p>	<p>Building E is the two storey women’s residence hall</p> <p>Location for its function - Well located in the accommodation zone adjacent to the student services facilities</p> <p>Quality and suitability of spaces for its function - – The rooms were designed for four students. This has been revised in practice to three students. There are 19 rooms with an ability to accommodate 57 students</p> <p>Disabled access - access only to the ground floor, toilets/showers not designed to be accessible</p> <p>Amenities, toilets - 8 toilets in total</p> <p>Building condition points - Targeted regular maintenance and cleaning to extend asset life. Repair water damage/leaks to ceiling/soffit immediately. Repair leaking AC unit and treat corrosion immediately. Refurbish floor finishes by 2023. Regularly maintain and replace mechanical, fire and special services by 2023</p> <p>Building age -17 years</p>

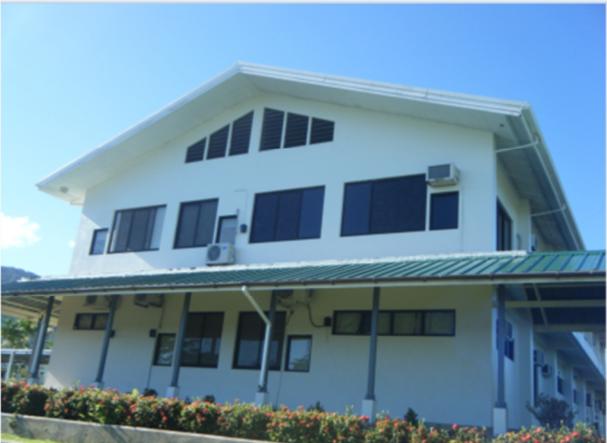
Building	Outline
<p>Building G – Administration</p>

<p>Building G is the administration building with admission and records, financial aid, VP and Presidents office and administration.</p> <p>Location for its function - In a good location within the academic zone – close to the main entry and car park</p> <p>Quality and suitability of spaces for its function – Has the ability to move functions within the space. Well laid out floor plan that enables students to access the ground floor for services. The server room and computer facilities may need expansion</p> <p>Disabled access - No access to the second floor is an issue and the stairs should ideally have wider treads as the pitch is steeper than anticipated for a general use stair</p> <p>Teaching spaces - nil</p> <p>Amenities, toilets - 2 mens/ 2 womens</p> <p>Building condition points - Targeted regular maintenance and cleaning to extend asset life. Treat rust and spot prime corroded gutters immediately. Replace roof by 2023. Refurbish floor, wall and ceiling finishes by 2023. Replace 1-2 AC window mounted units immediately.</p> <p>Building age – 17 years</p>

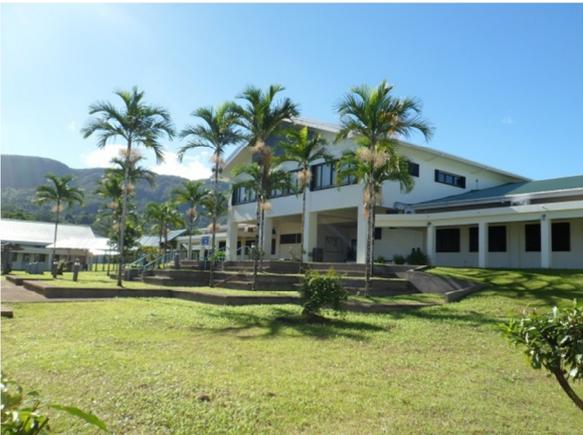
<p>Building H - Learning Resources Centre and MITC</p>

<p>Building H is the LRC building with the library, computer lab and MITC.</p> <p>Location for its function – The central location at the top of the hill give this function primacy in the campus.</p> <p>Quality and suitability of spaces for its function – The MITC is often used by others so the addition of toilets accessible after hours located where the current darkroom is would make this area work better for users</p> <p>Disabled access -Two disabled car parks directly behind the building, lift provided to the second floor, access to the other buildings is provided but not as direct as the covered walkways</p> <p>Teaching spaces – nil, two rooms with a partition in the MITC area are available for use but not timetabled</p> <p>Amenities, toilets - 2mens/2womens/2 unisex</p> <p>Building condition points - Targeted regular maintenance and cleaning to extend asset life. Treat rust and spot prime corroded roofing and re-paint immediately. Repair wheel chair lift (Health & safety issue). Review membrane roofing repair/installation requirements to canopies.</p> <p>Building age – 17 years</p>

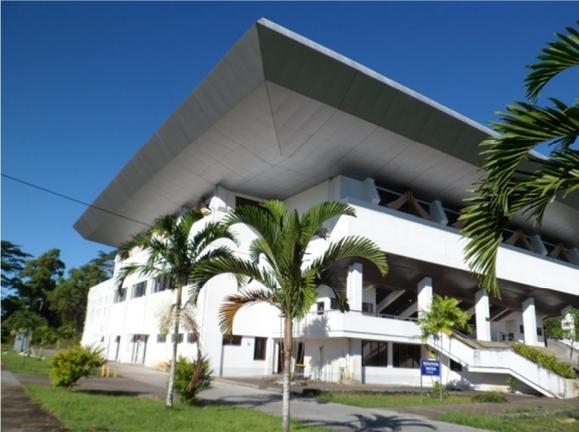
Building	Outline
<p>Building L – FSM – China Friendship Sports Centre</p>

<p>Points to consider for future planning – Targeted improvements required including making the meeting space more visible (signage/ landscaping) and improving the internal fit out and upgrading the exterior</p>	<p>Building L is the Sports Centre</p> <p>Location for its function – Located in its own area with large surrounding car park</p> <p>Quality and suitability of spaces for its function – The smaller hall at the back of the building is remote however due to the size of the building any modifications would be sizeable and so improving the building finishes rather than moving functions around would be of more benefit</p> <p>Disabled access -</p> <p>Teaching spaces -</p> <p>Amenities, toilets - 8 men’s wc/ 9 urinals/ 5 showers 8 womens WC/ 5 showers 1 disabled WC</p> <p>Building condition points - Windows and doors In very poor condition. This is a major health and safety risk as window/glazing may fall out. Replace immediately. PVC Down Pipes and metal rain water heads Rain water heads corroding and leaking. Downpipes in poor condition, some are missing and others damaged. Repair & replace to prevent staining of external walls Solid Plaster Cladding with Painted Finishes Evidence of leaking/cracks with significant amount of mould growing on external walls. Repair leaks and clean Insitu Concrete Slab Roof Without Any Apparent Membrane Waterproofing Roughly placed with poor quality finish, cracks in places. Install new roof membrane immediately to prevent further damage/deterioration Building age -12 years, early 2000s</p>

1. China Friendship Sports Centre. 31% of the operational costs are dedicated to this building which has a condition grade 4 highlighting that it is in poor condition and is showing signs of significant failure. Replacement windows (a health and safety issue) and the repair of leaks are required urgently. This asset needs specific funding to prevent deterioration and to extend its life.

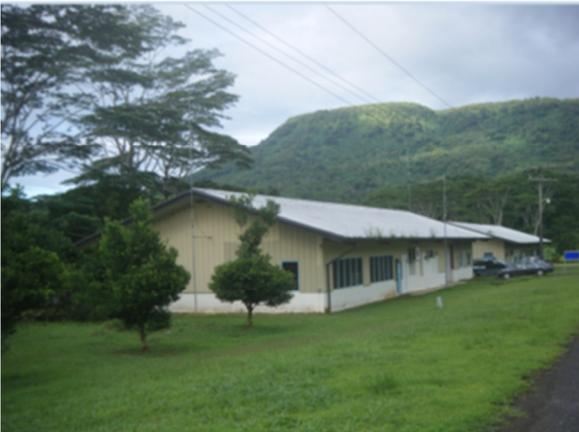
<p>Building M – Security, Weights Room, IT Shop</p>

<p>Points to consider for future planning – Security could move to a more central location to reduce response time. Potential for file storage facility - overflow from the administration</p>	<p>Building M has a range of uses and has been converted into IT shop, weights room and security area</p> <p>Location for its function – The security function works closely with the maintenance staff in the adjacent building</p> <p>Quality and suitability of spaces for its function – Provides an open space which can be subdivided into a range of functions - an asset on a campus of this size</p> <p>Disabled access - level access</p> <p>Teaching spaces - nil</p> <p>Amenities, toilets - nil</p> <p>Building condition points - Some minor concrete spalling needs repair. Replace corroded roofing immediately and consider re-painting roof. Gutters and downpipes need replacing. Building age – 17 years, mid 1990s</p>

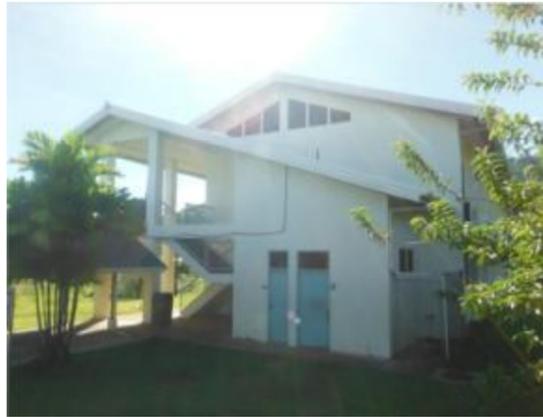
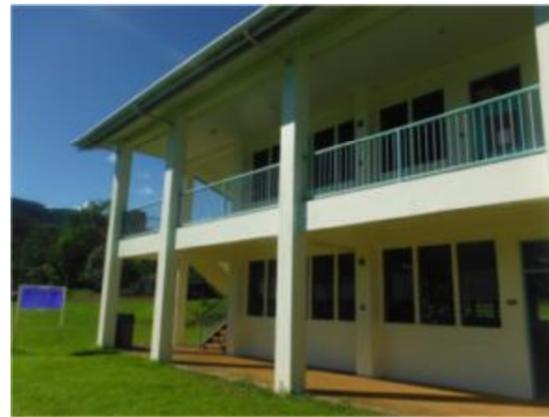
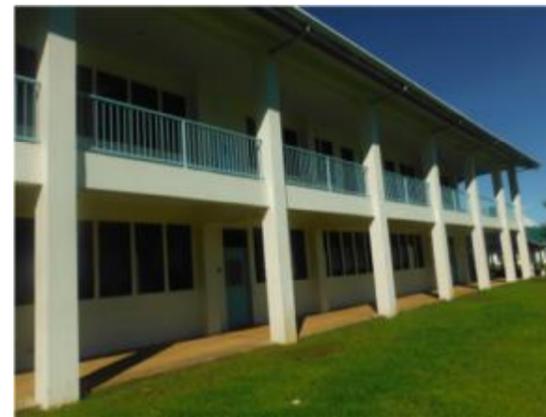
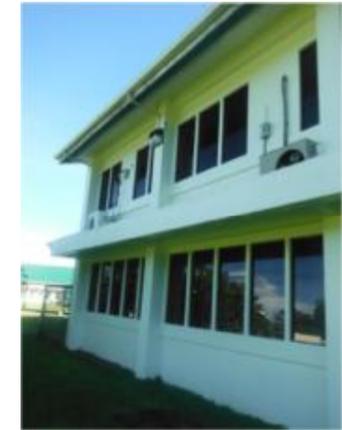
A – SPECIALIZED CLASSROOM

1.00	Total Sub-Structure	3	50%						0	0	0	0	145,390	0.0%		
2.00	Total Frame	2	30%						0	0	0	0	320,448	0.0%		
3.00	Total Structural Walls	2	30%						0	0	0	0	128,303	0.0%

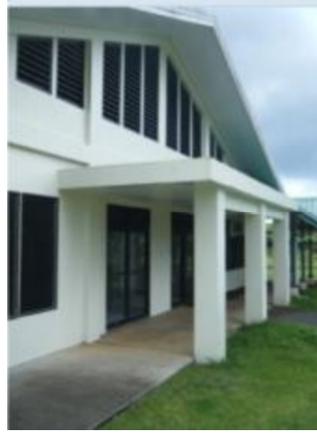
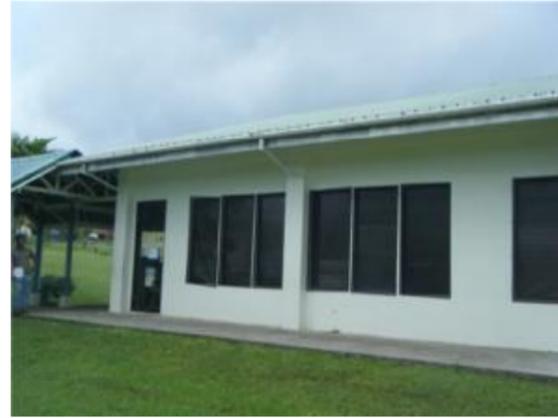
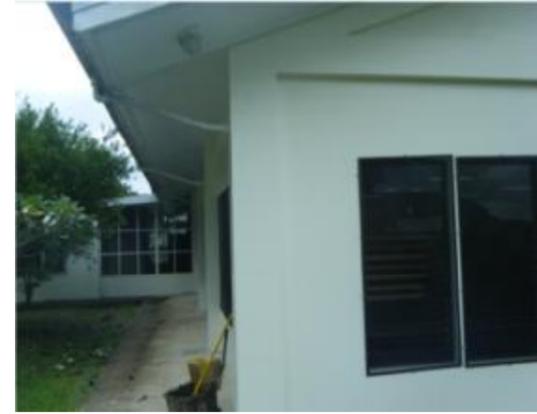
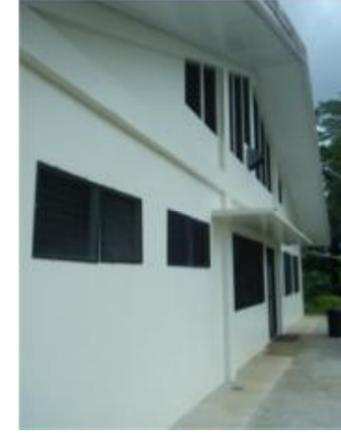
C – DINING HALL

1.00	Total Sub-Structure	2	30%						0	0	0	0	166,789	0.0%
2.00	Total Frame	2	30%						0	0	0	0	456,316	0.0%
3.00	Total Structural Walls	2	30%						0	0	0	0	78,626	0.0%

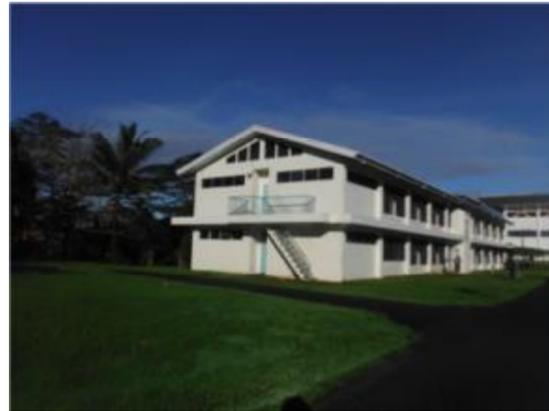
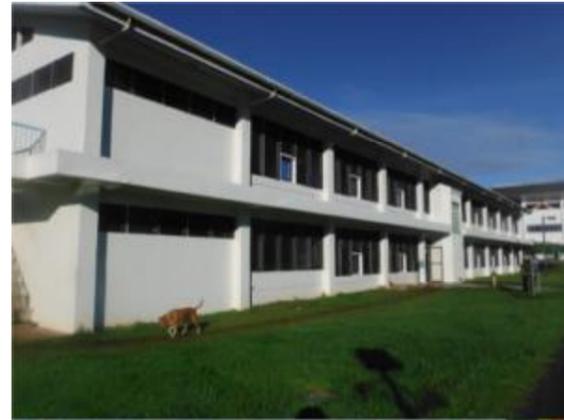
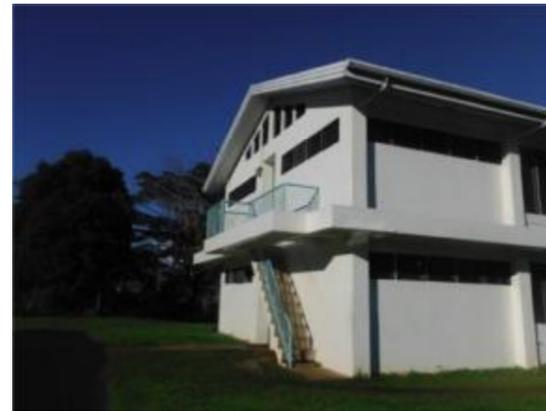
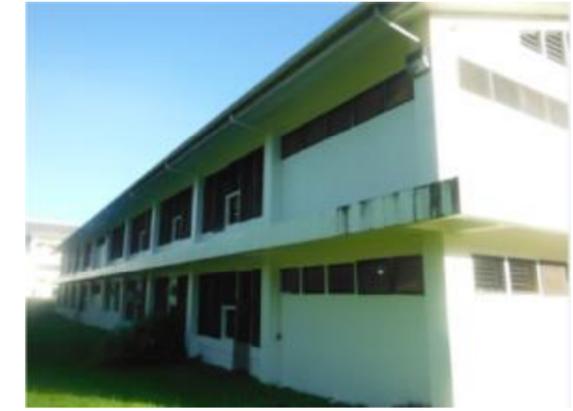
D – MEN’S RESIDENCE HALL

1.00	Total Sub-Structure	2	30%						0	0	0	0	251,000	0.0%
2.00	Total Frame	2	30%						0	0	0	0	208,170	0.0%
3.00	Total Structural Walls	2	30%						0	0	0	0	280,628	0.0%

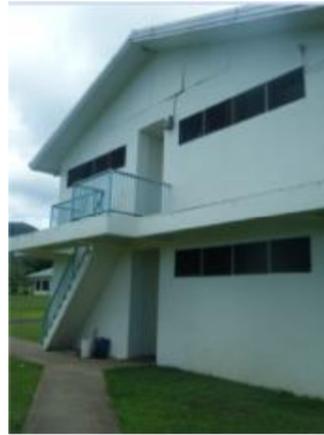
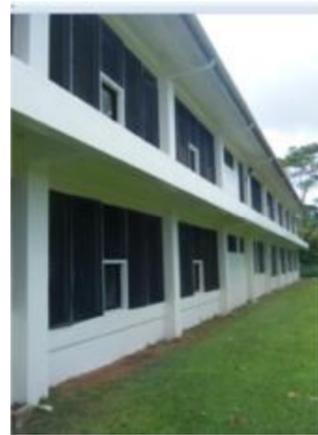
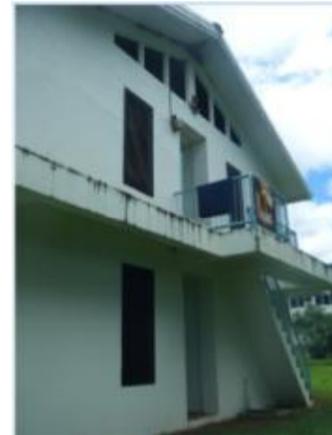
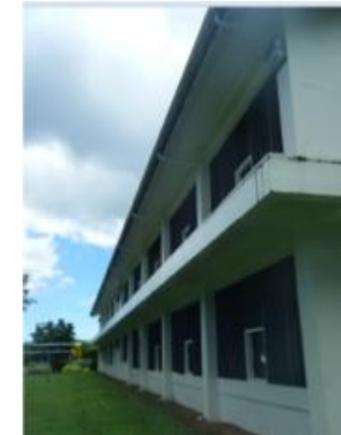
E – WOMAN'S RESIDENCE HALL

1.00	Total Sub-Structure	2	30%						0	0	0	0	201,560	0.0%	Element	Observed Deterioration/Recommendations
2.00	Total Frame	2	30%						0	0	0	0	172,451	0.0%

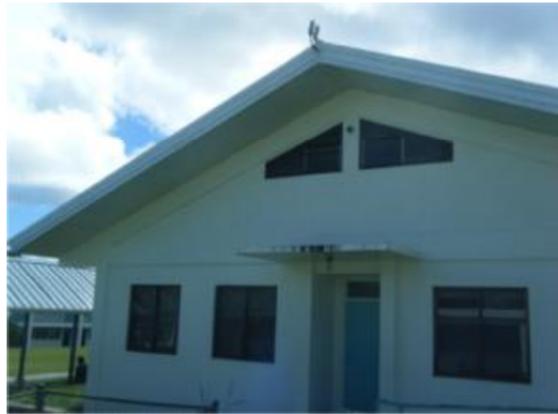
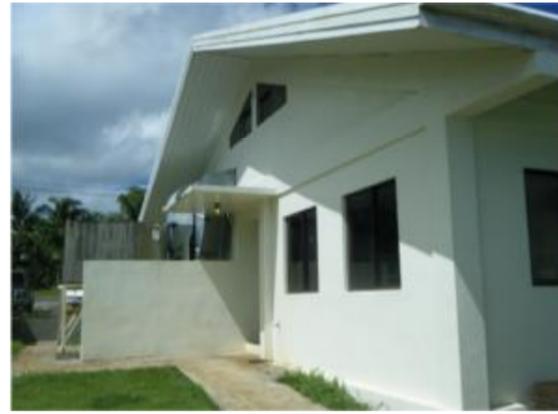
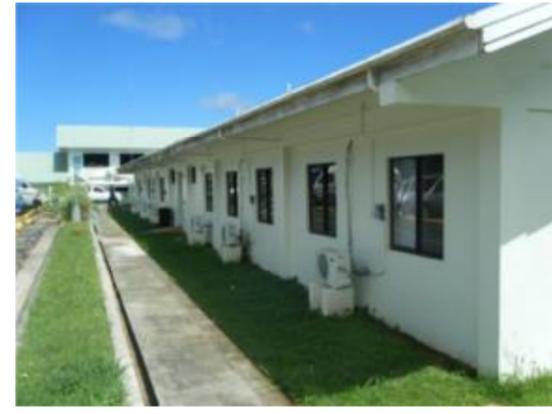
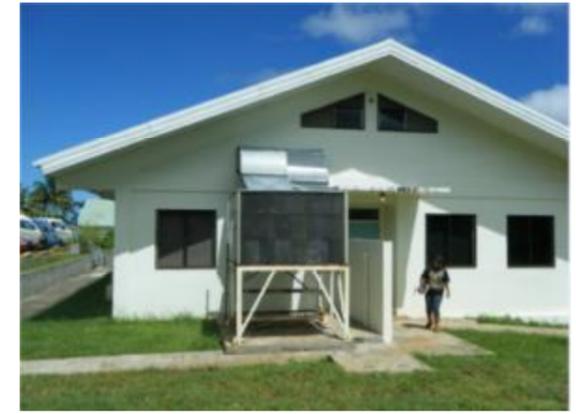
F2 - FACULTY OFFICE (NEW)

1.00	Total Sub-Structure	3	50%						0	0	0	0	136,415	0.0%		
2.00	Total Frame	2	30%						0	0	0	0	145,319	0.0%		
3.00	Total Structural Walls	0	0%						0	0	0	0	0	0.0%

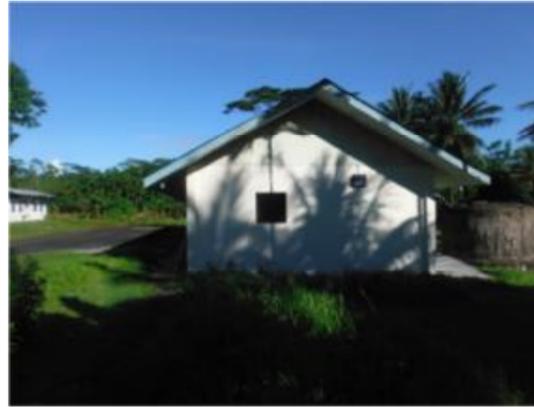
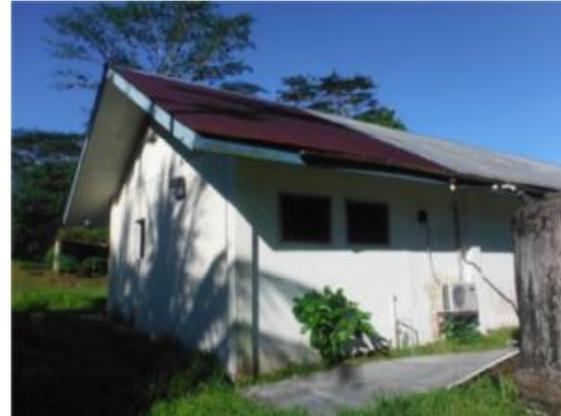
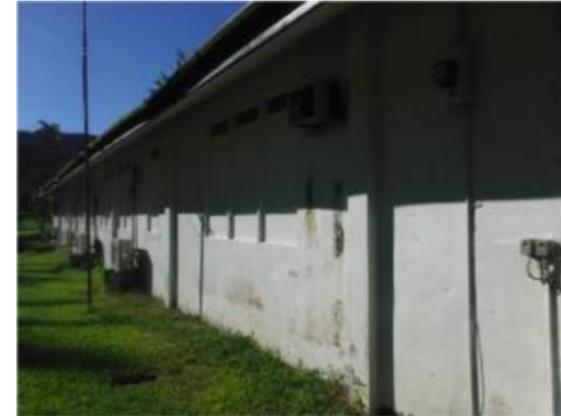
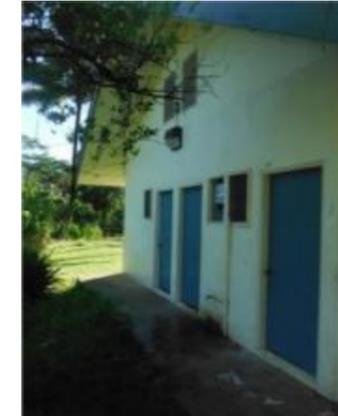
I - AGRICULTURE

1.00	Total Sub-Structure	2	30%						0	0	0	0	97,013	0.0%	Element	Observed Deterioration/Recommendations	
2.00	Total Frame	2	30%						0	0	0	0	182,513	0.0%

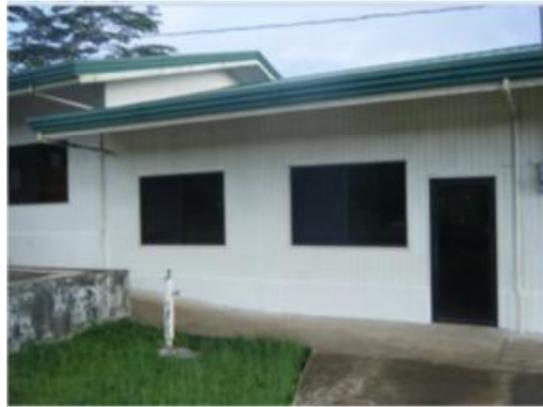
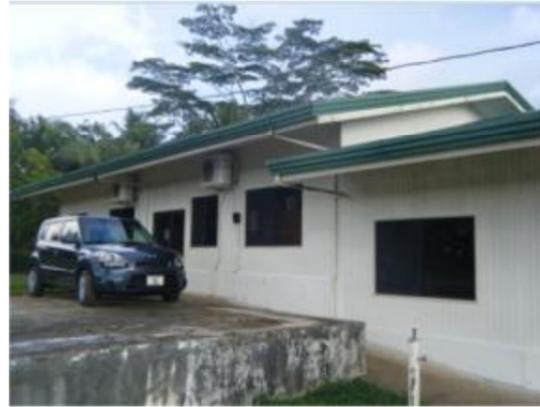
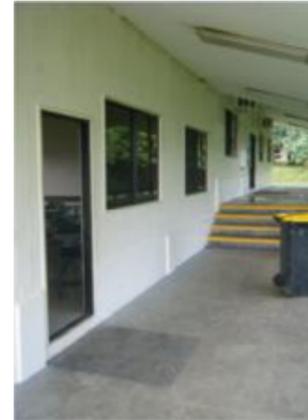
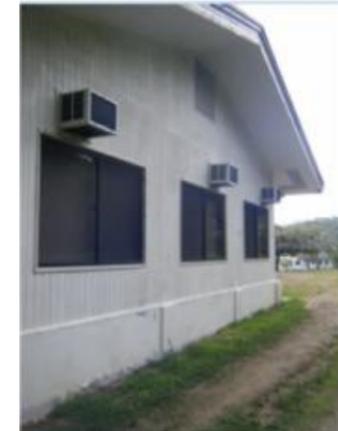
J - A+ CENTER & ARE CLASSROOM

1.00	Total Sub-Structure	2	30%						0	0	0	0	106,516	0.0%
2.00	Total Frame	2	30%						0	0	0	0	87,311	0.0%
3.00	Total Structural Walls	0	0%						0	0	0	0	0	0.0%

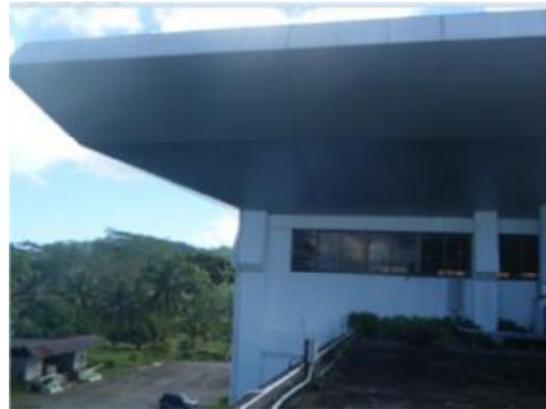
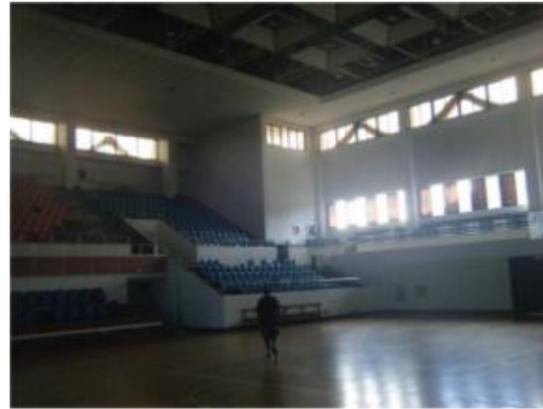
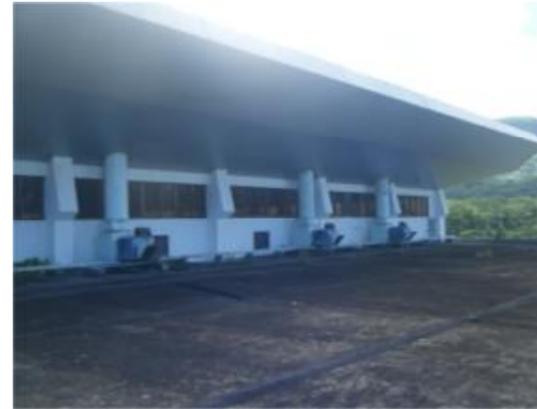
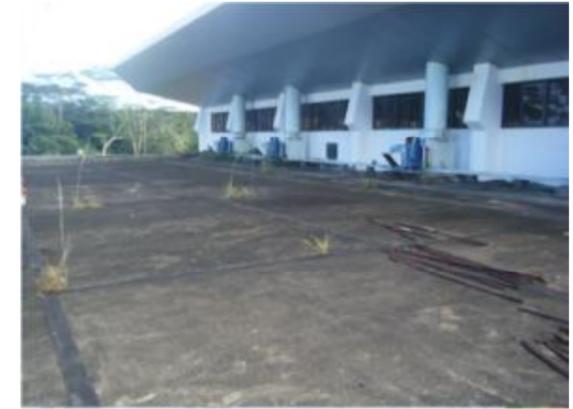
L – FSM – CHINA FRIENDSHIP SPORTS CENTER

1.00	Total Sub-Structure	3	50%						0	0	0	0	598,673	0.0%	PVC Down Pipes and metal rain water heads	Rain water heads corroding and leaking. Downpipes in poor condition, some are missing and others damaged. Repair & replace to prevent staining of external walls

5.00	Total Roof	5	90%						518,648	0	0	518,648	518,648	100.0%		
6.00	Total External Walls & Finishes	4	70%						0	395,747	0	395,747	395,747	100.0%	Solid Plaster Cladding with Painted Finishes	Evidence of leaking/cracks with significant amount of mould growing on external walls. Repair leaks and clean

7.00	Total Windows & Doors	5	90%						516,192	0	0	516,192	516,192	100.0%		
A	TOTAL STRUCTURE	4	70%						1,034,841	680,782	0	1,715,623	6,681,605	25.7%	Insitu Concrete Slab Roof Without Any Apparent Membrane Waterproofing	Roughly placed with poor quality finish, cracks in places. Install new roof membrane immediately to prevent further damage/deterioration

10.00	Total Internal Doors	4	70%						0	45,540	0	45,540	45,540	100.0%	Windows and Doors	In very poor condition. This is a major health and safety risk as window/glazing may fall out. Replace immediately

11.00	Total Floor Finishes	4	70%						0	99,681	0	99,681	99,681	100.0%		
12.00	Total Wall Finishes	4	70%						740,091	0	0	740,091	740,091	100.0%	Concrete Screed Floor Finish	Worse for wear, cracks and chips

13.00	Total Ceiling Finishes	3	50%						0	544,552	0	544,552	544,552	100.0%		
14.00	Total Fixed Joinery Units	4	70%						9,488	78,506	0	87,993	87,993	100.0%	Overall Recommendation/Action	Targeted regular maintenance and cleaning to extend asset life. Replace roof and windows (Health & safety issue) immediately. Repair wall leaks/cracks, gutters and downpipes immediately. Regularly maintain and replace sanitary plumbing, mechanical and fire services by 2023
B	TOTAL INTERNAL FIT-OUT	4	70%						749,579	768,280	162,806	1,680,664	2,075,850	81.0%

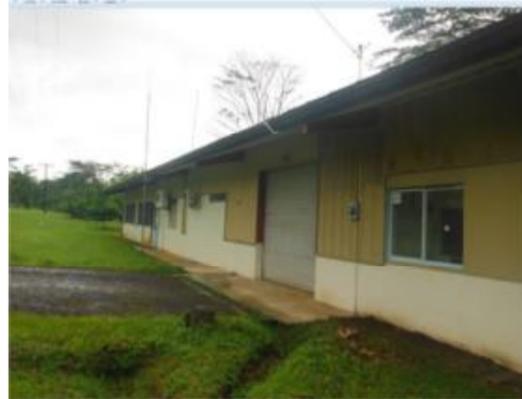
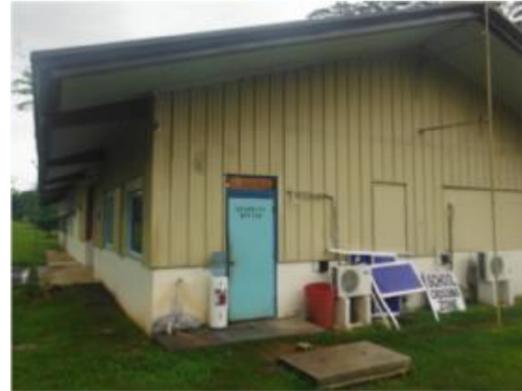
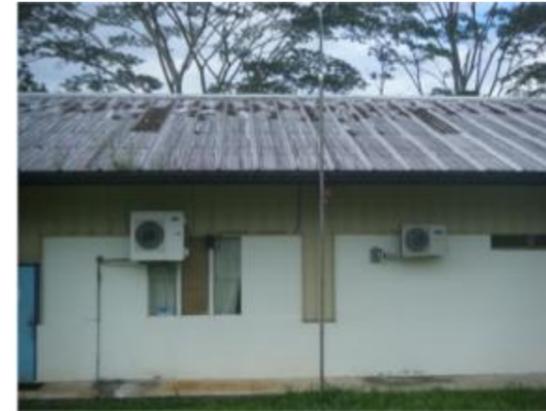
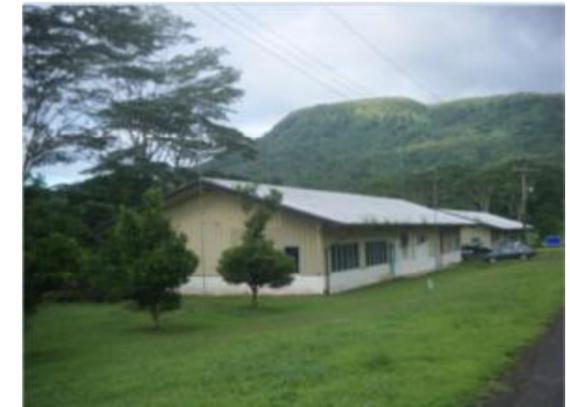
M - SECURITY, WEIGHTROOM, BOOKSTORE & IT

TOP 5 MAJOR ELEMENTS REQUIRING URGENT MAINTENANCE, RENEWAL OR REPLACEMENT	
Element	Observed Deterioration/Recommendations
Metal Gutters	Rusted and needs replacing
Metal Down Pipes	7 of 8 have corroded and need replacing
Profiled Metal Sheet Wall Cladding (Pre-Finished)	Flaking paint and corrosion, especially at back. Replace corroded roofing immediately and consider re-painting roof (roof due for replacement by 2023)
Timber Doors (Solid/No Glazing)	Leafs in poor condition. Frames need repairs in places
Profiled Metal Sheet Soffit Lining (Pre-Finished)	Corrosion to fixings and edges.
Overall Recommendation/Action	Targeted regular maintenance and cleaning to extend asset life. Some minor concrete spalling needs repair. Replace corroded roofing immediately and consider re-painting roof. Replace roof, gutters, downpipes, windows and doors by 2023. Repair wall cracks and repaint by 2023, Regularly maintain and replace mechanical, fire and special services by 2023

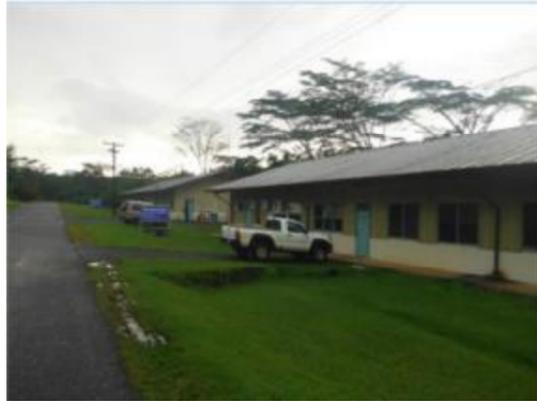
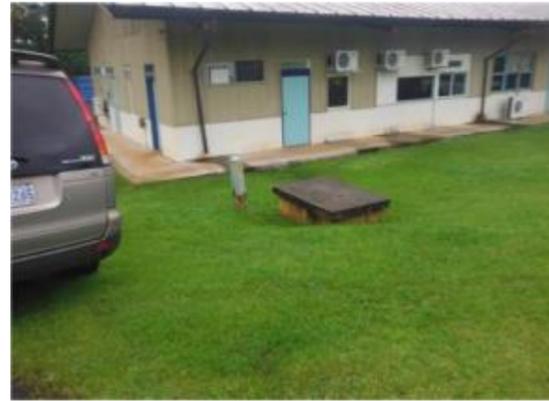
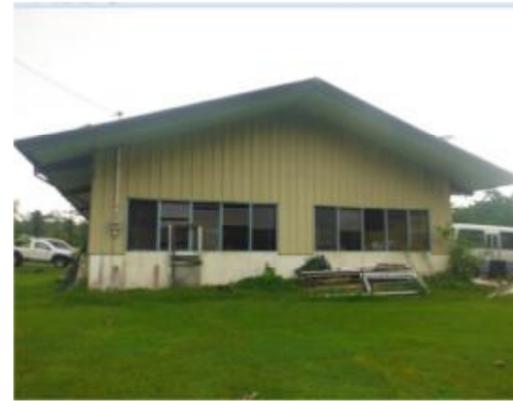
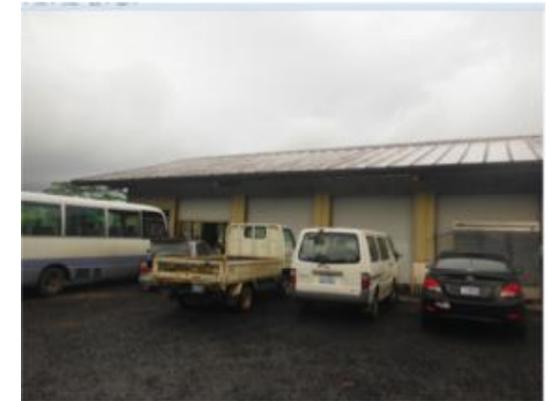
N - MAINTENANCE CRE, MUSIC CLASSROOM

Element	Observed Deterioration/Recommendations
Metal Doors (Solid/No Glazing)	Two severely corroded on face, edges and hinges. Others show signs of corrosion beginning. Frames Ok but need maintenance.
Profiled Metal Sheet Soffit Lining (Pre-Finished)	Corrosion to fixings and edges.
Metal Gutters	Evidence of corrosion, some holes visible.
Profiled Metal Sheet Wall Cladding (Pre-Finished)	Corrosion established in several places. Holes and damage also evident. Repair /replace roofing in selected areas and consider re-painting roof (roof due for replacement by 2023)
Aluminium Framed Windows	More recently installed. Some broken glass, frames faded but OK
Overall Recommendation/Action	Targeted regular maintenance and cleaning to extend asset life. Localised roof, gutter and soffit repairs or rust treatment required immediately. Consider re-painting roof. Replace roof, gutters, downpipes, windows and doors by 2023. Refurbish internal door, wall and ceiling finishes by 2023, Regularly maintain and replace mechanical, fire and special services by 2023
